IX-G2 Poultry Solutions

X-ray inspection system

The fast, reliable route to bone-free poultry fillets

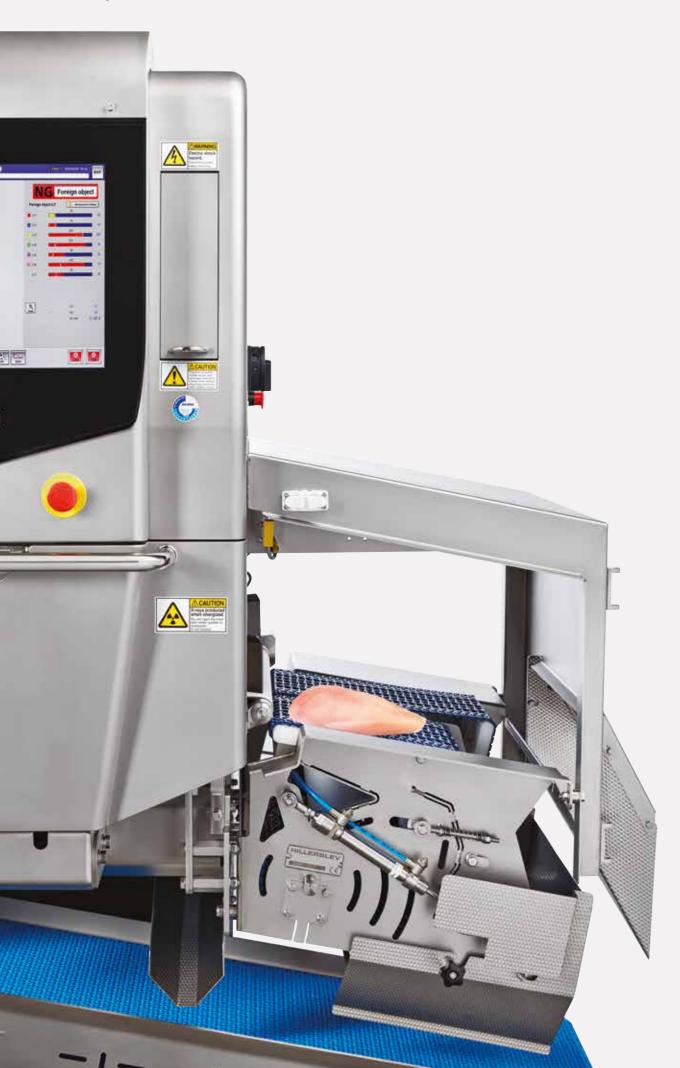
The ability to measure at both the high and lower energy levels allows a composite image to be constructed that effectively removes the product effect and highlights the areas containing even the smallest bone fragments.

Chicken fillet inspection with the wish bone

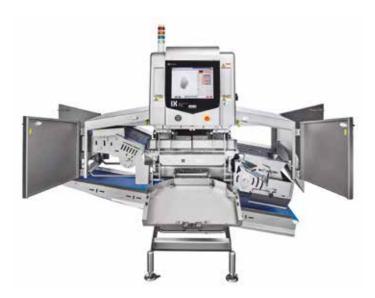
The IX-G2 solution is available in both single and dual lane variants depending on the individual application requirements giving throughputs in excess of 220 fillets per minute.

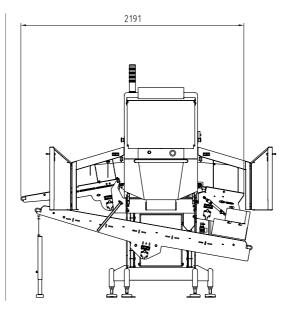
Inspection area

Product Size (mm)			
Height	Width		
0	400		
10	392		
20	385		
30	378		
40	371		
50	364		
60	357		
70	350		
80	343

The figures show the permissible inspection range. Portions of the product which are not within the shaded area are not irradiated.

*Aperture height is 150mm. Maxin	num passable product height is 80mm.
----------------------------------	--------------------------------------
